ARCHITECTURAL HERITAGE IMPACT ASSESSMENT

PROPOSED APARTMENT DEVELOPMENT AT SWORDS ROAD / SANTRY AVENUE, SANTRY, DUBLIN 9

DERMOT NOLAN
CONSERVATION ARCHITECT

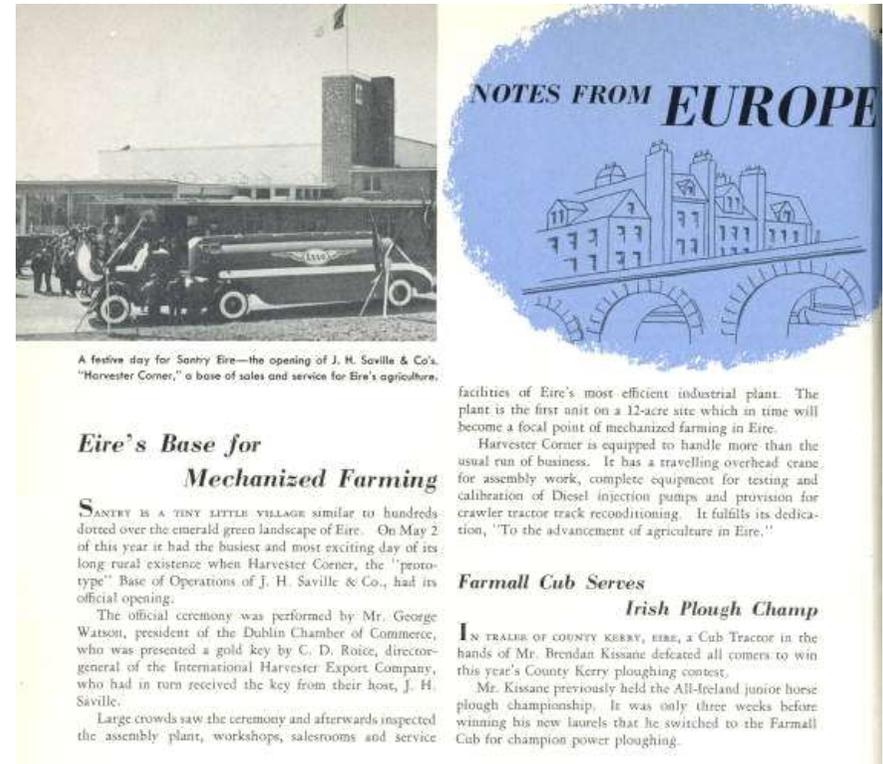
PIC. 3; EXCERPT FROM WISCONSIN HISTORICAL SOCIETY YEARBOOK (PHOTO OF BUILDING TAKEN ON INAUGURATION DAY, 2ND MAY 1951).

An article in a handbook published by International Harvesters confirmed that the premises were, indeed, used as “assembly plant, workshops, salerooms and service facilities”. This handbook (relevant page on right describes the opening of the plant) was uncovered in the Wisconsin Historical Society’s website. Wisconsin was and is, of course, a state with a huge agricultural economic base, IH had large premises in the state.

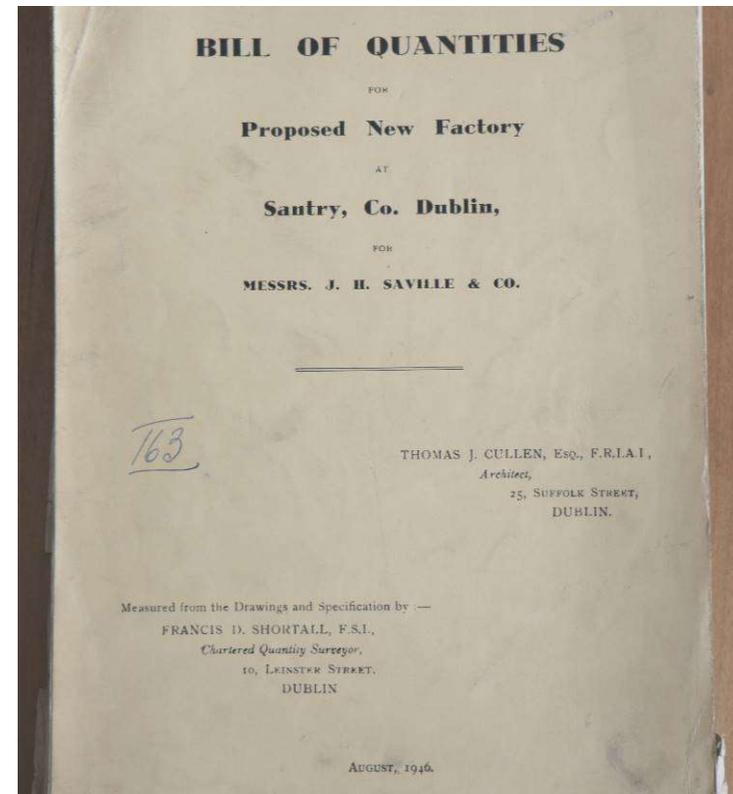
PIC. 5; BILL OF QUANTITIES, FRONT PAGE. NOTE THAT THIS WAS PREPARED FOR ORIGINAL ARCHITECT, T. J. CULLEN.

Patterson Kempton Shortall were the Quantity Surveyors. The Archive held the original Bill of Quantities which was prepared for Thomas J. Cullen, while the Final Account, also held by the Archive, was addressed to his replacement, Nolan & Quinlan.

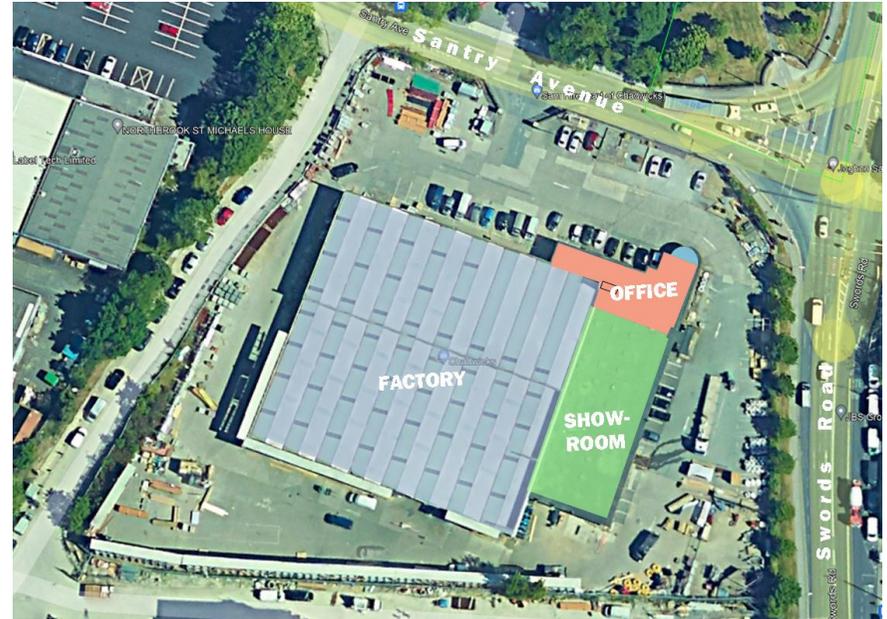
PIC. 8; GOOGLE EARTH IMAGE, WITH OVERLAY

These three distinct functions are indicated, in spatial terms, in PIC 8. They are distinguished on this Google Earth screenshot by coloured overlays, as follows: offices (orange), showrooms (green) and factory (blue).

As seen in FIG. 8 below, it was clearly originally divided into three separate areas, each with its own distinct function, as follows:

- The **office** element is located to the north-east of the complex and forms the more visually prominent corner; it has brick-faced walls, was partially two-storey, and has concrete floors and roof.
- South of this, also on the east side, facing the Swords Road, is the single-storey **showroom** section, a concrete-framed structure.
- The westernmost element, the **factory**, is a large (c. 3,000sq. m.) single-storey, steel framed, pitched roof, multi-bay structure. This was the most utilitarian element, which accommodated the storage, assembly and repair of vehicles and machinery.

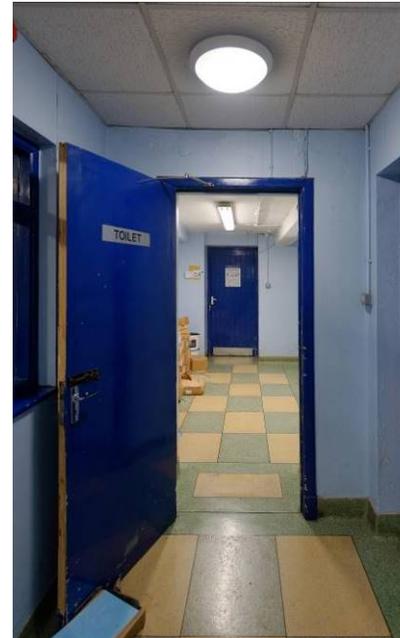
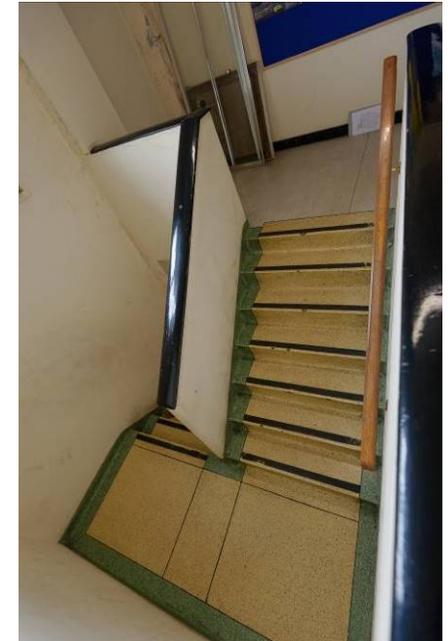
PICS 9 & 10; TERRAZZO (CORRIDOR & STAIRS) IN OFFICE SECTION.

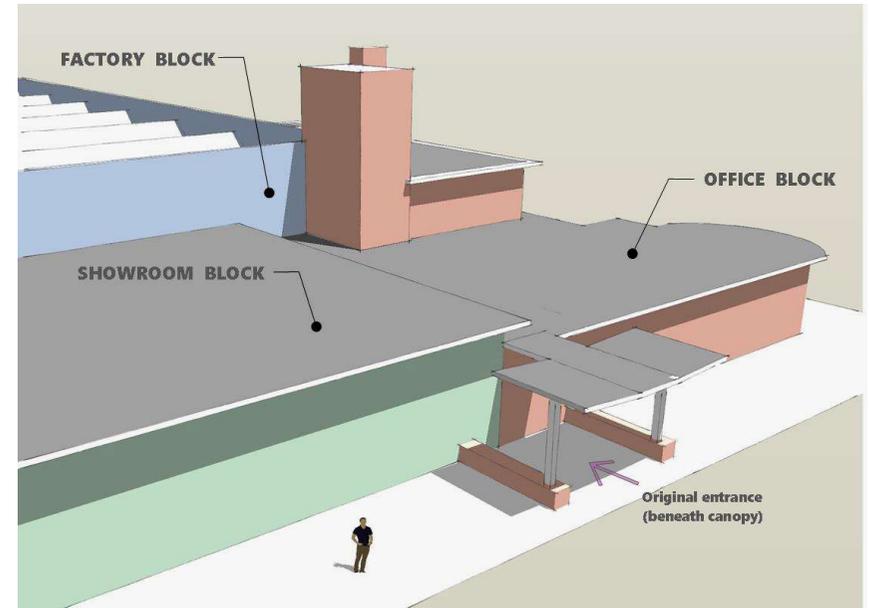
PIC 14; AERIAL VIEW FROM EAST.

It will be seen that, for clarity's sake, the colouring is the same as the overlay used in PIC. 8 (Google Earth image).

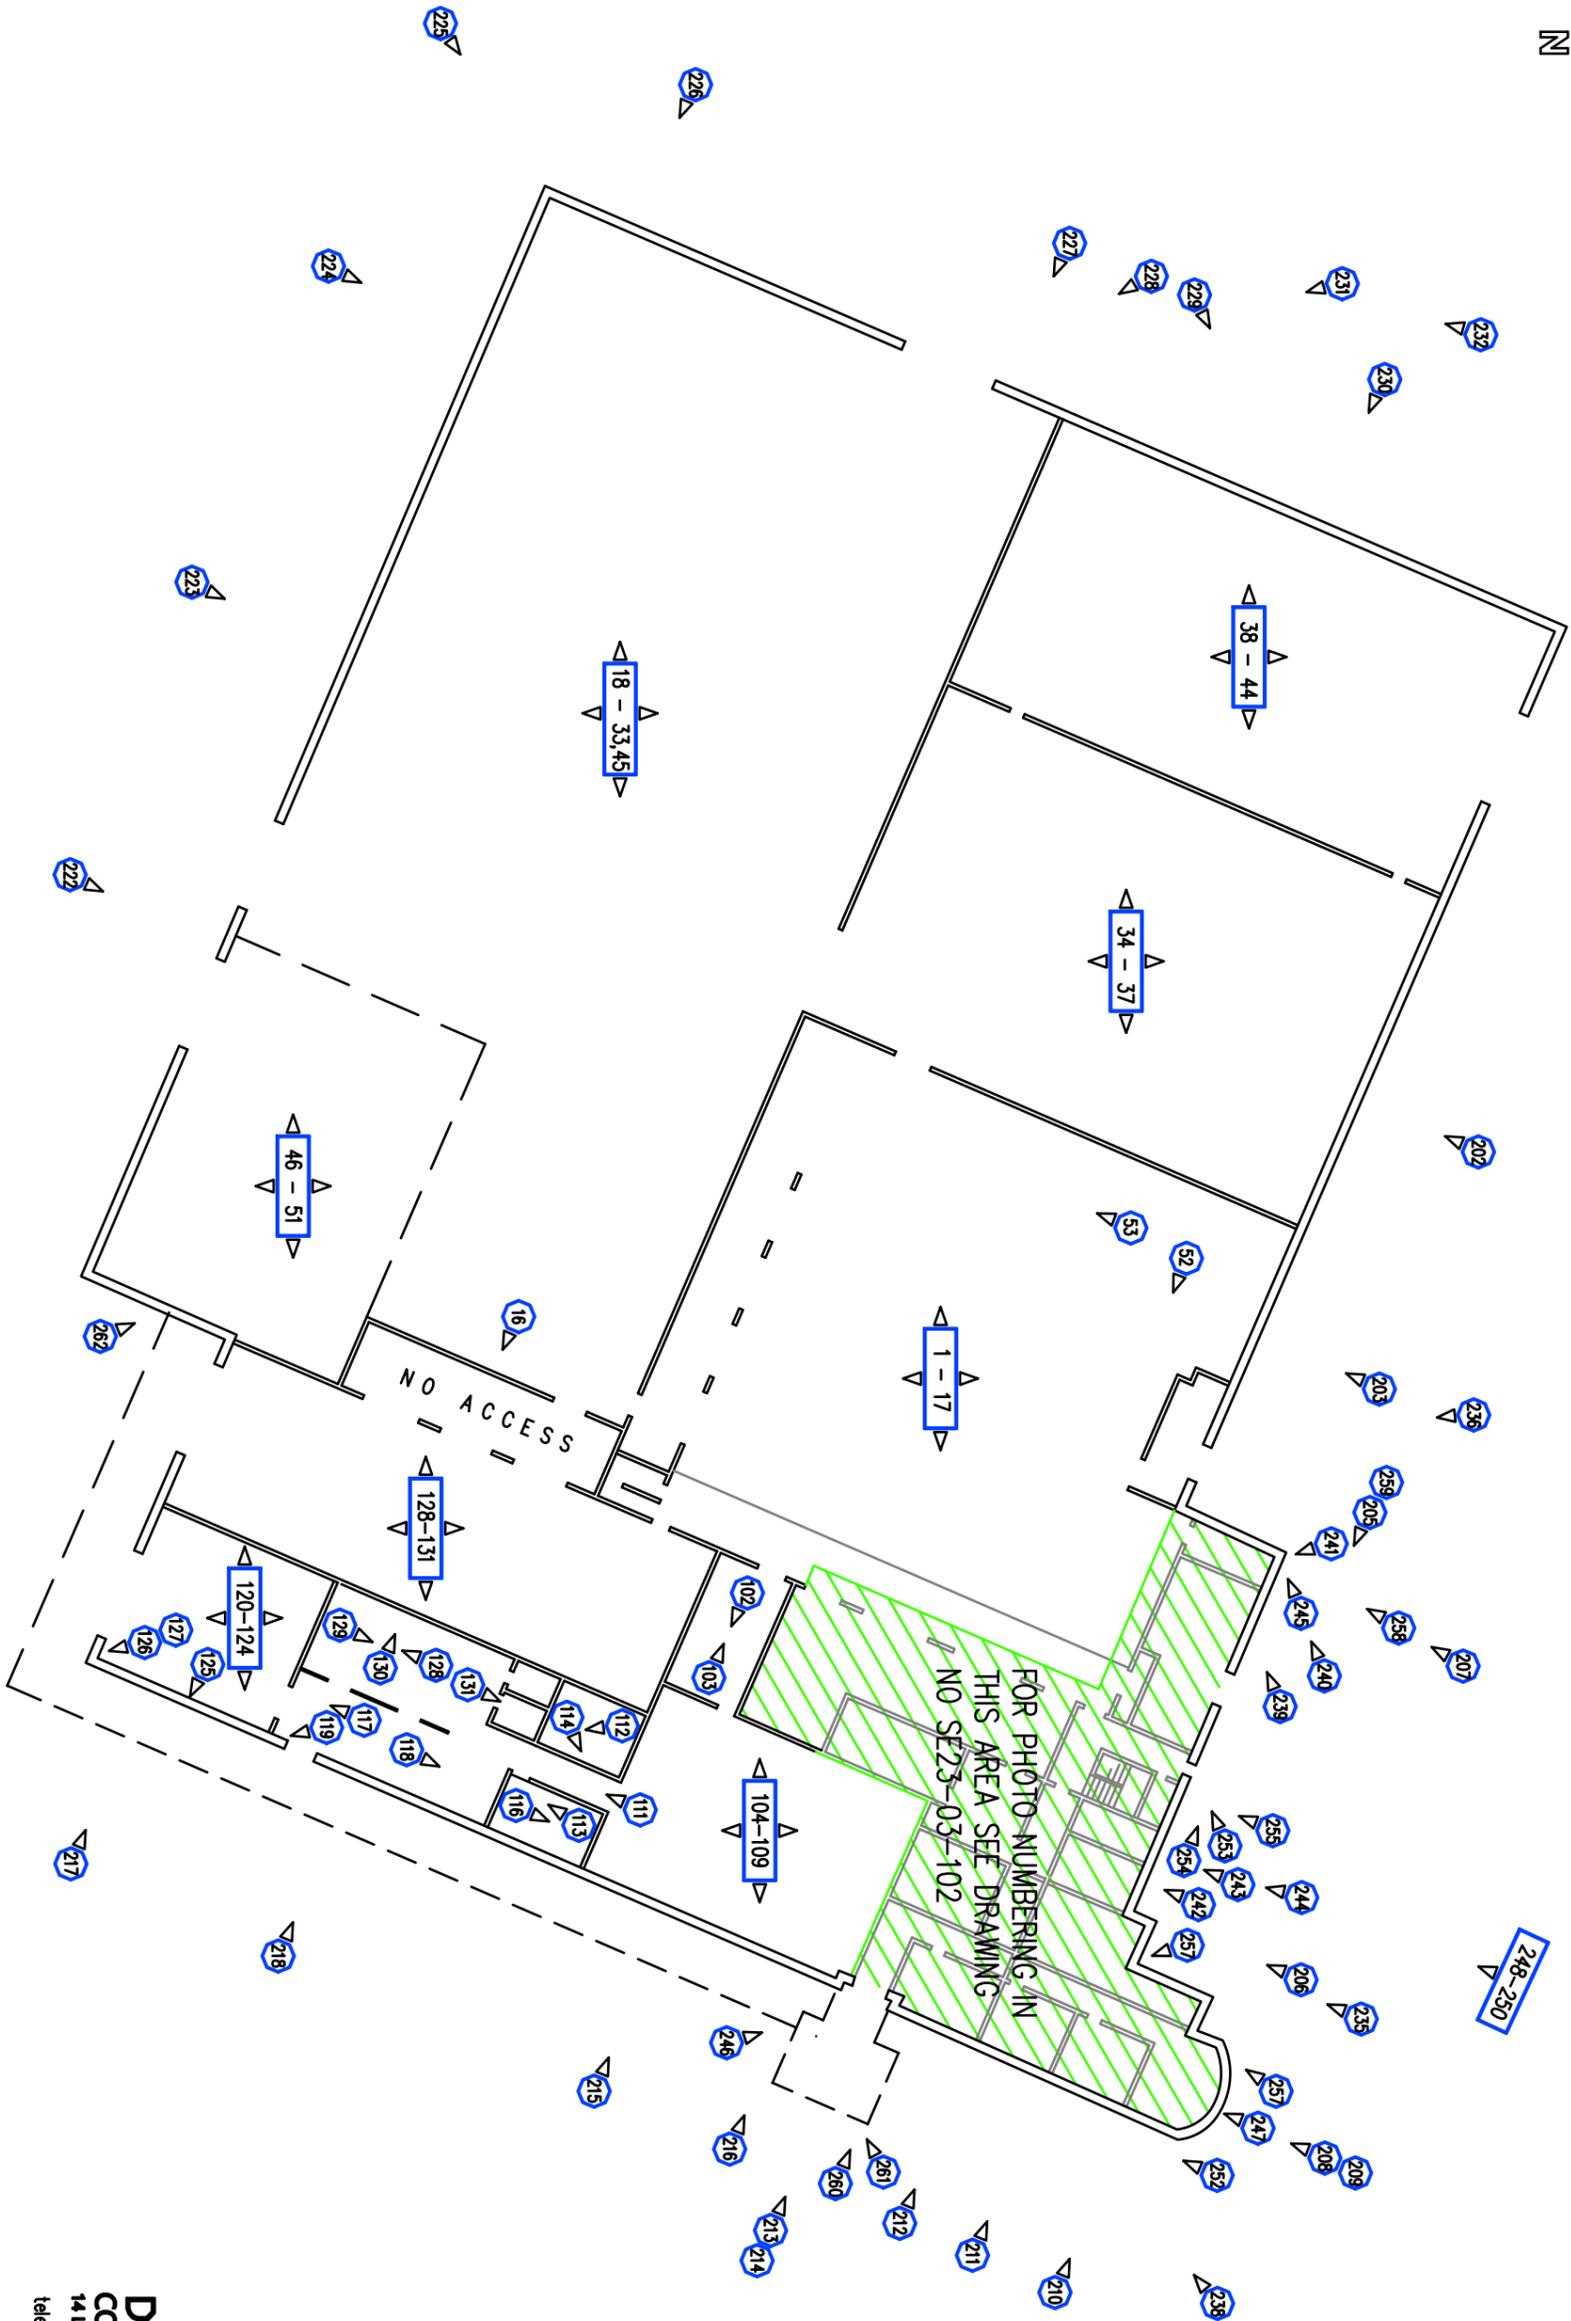
GROUND FLOOR PLAN

International Harvester (Soville's) Building at
 Swords Road / Santry Avenue, Santry, Dublin 9
 Base drawing ref D1809.P02 by Dovey & Smyth
 Architects, photograph numbering annotation by
 Dermot Nolan
 Scale: NOT TO SCALE Dwg No: C23-03-101

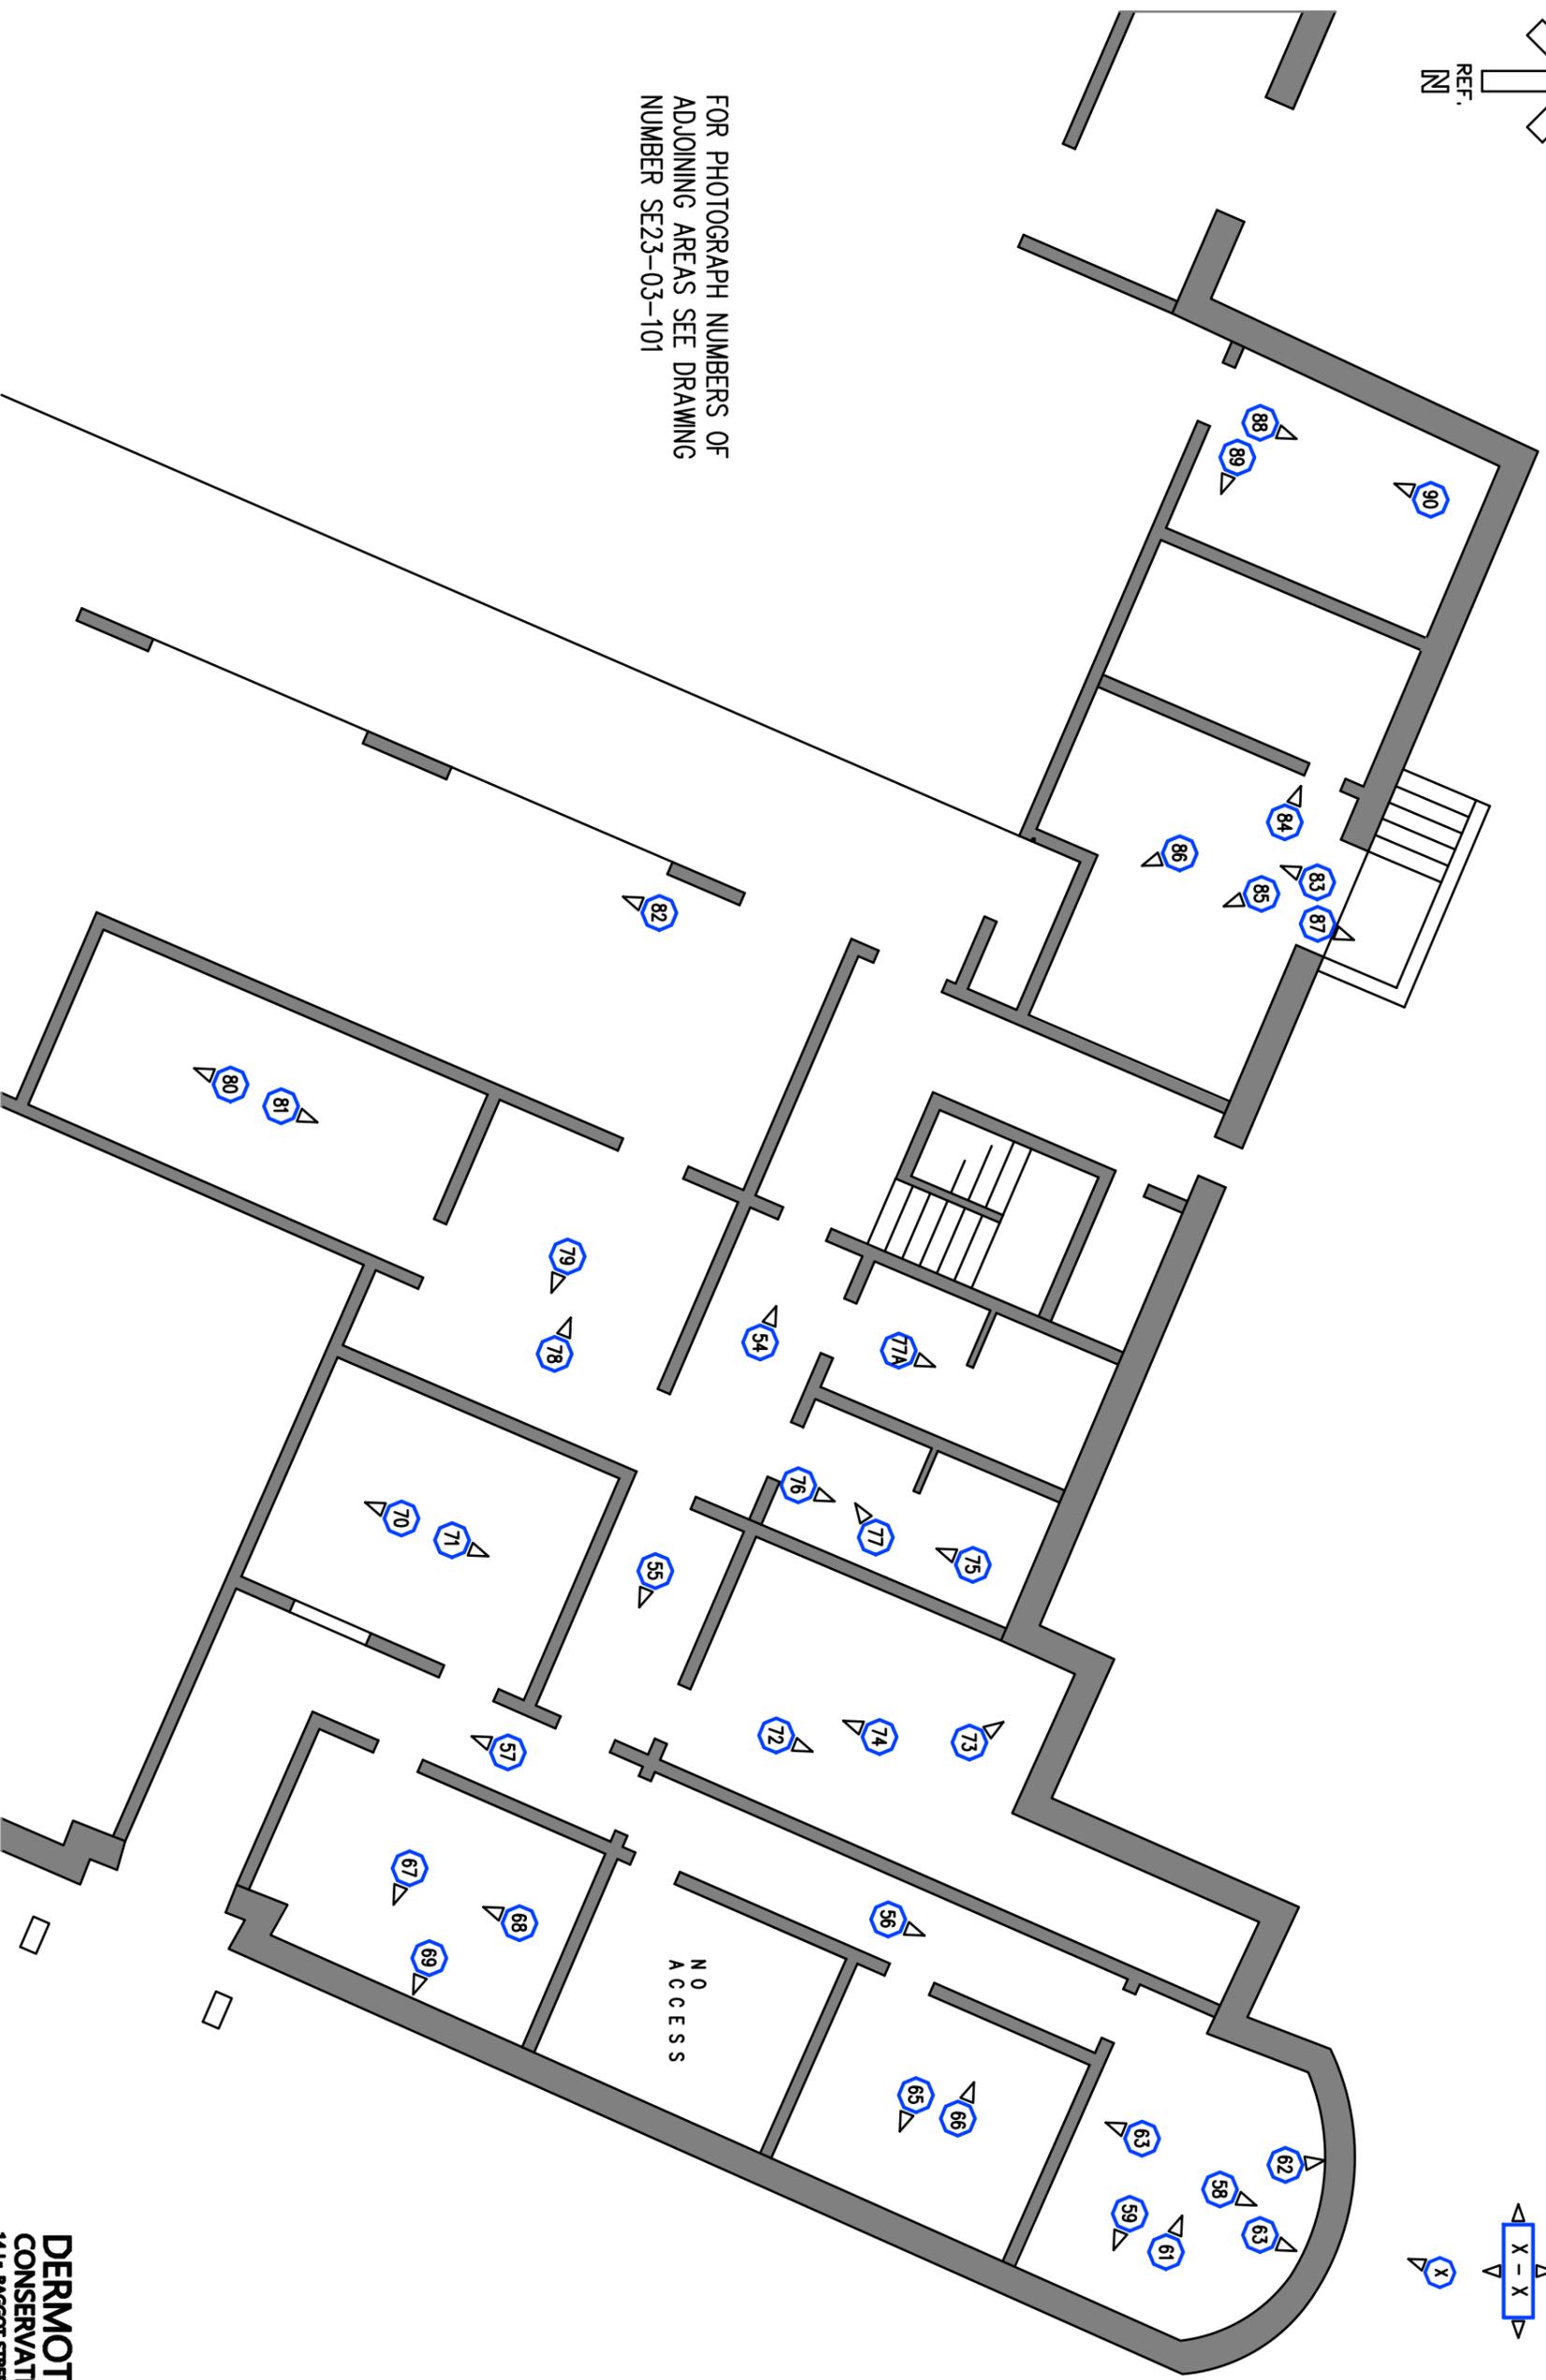
PART GROUND FLOOR PLAN ENLARGED

International Harvester (Saville's) Building at
Swords Road / Santry Avenue, Santry, Dublin 9
Base drawing ref D1809.P02 by Dawy & Smyth
Architects, photograph numbering annotation by
Dermot Nolan

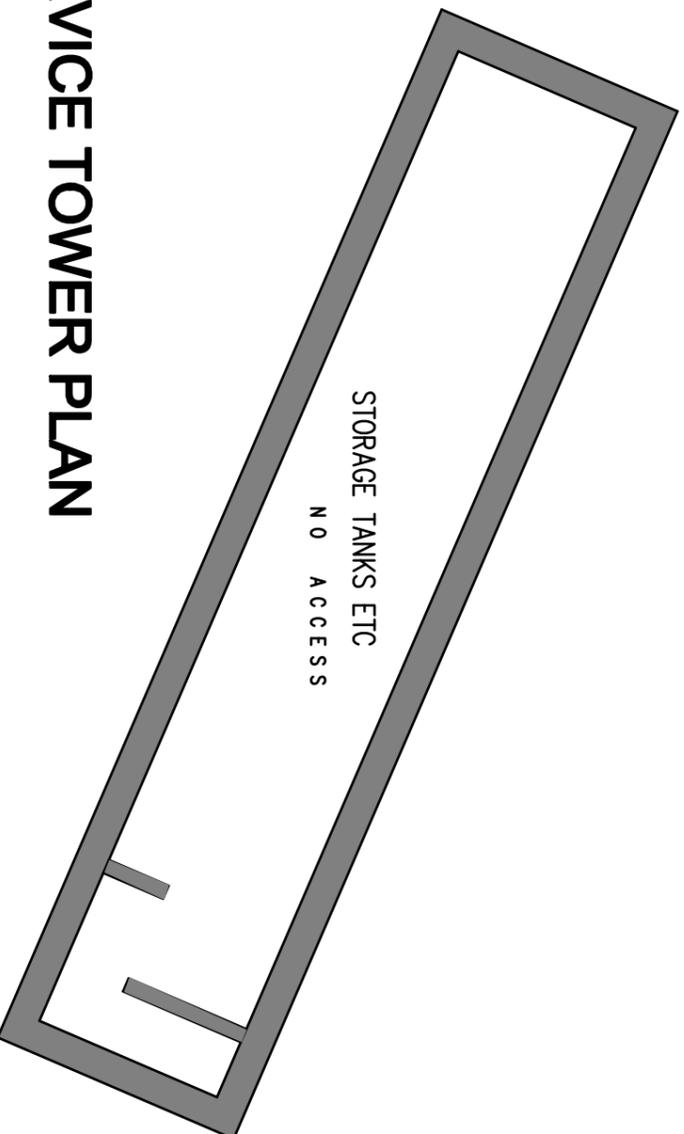
SERVICE TOWER PLAN

STORAGE TANKS ETC
NO ACCESS
